RESEARCH REPORT

Assessment of Asbestos Containing Materials in Idaho Bridges

RP 283

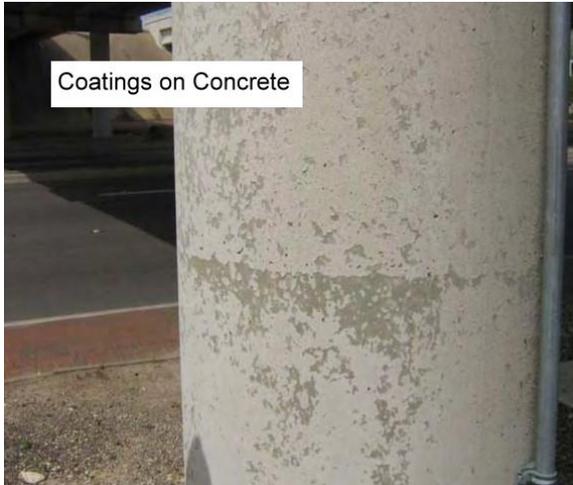
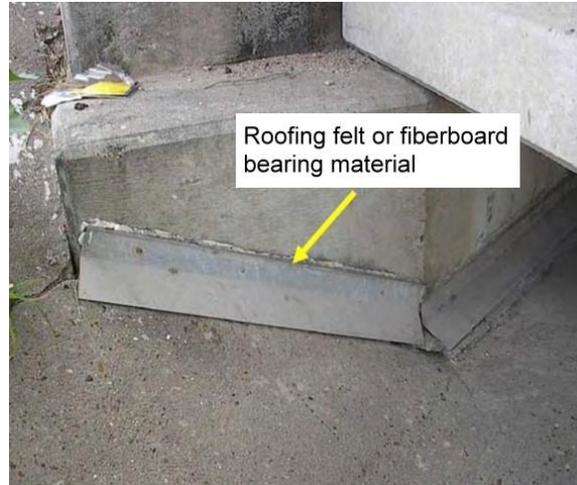
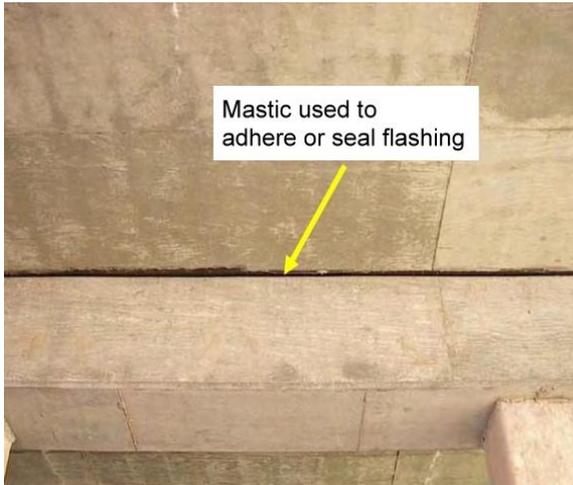
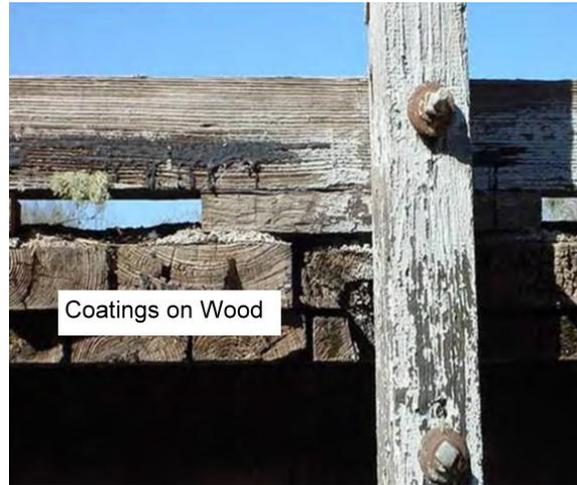
Figure 2.1 Common sources of Asbestos found in bridges (Morse, et al. 2008). (a) shows potential asbestos coating on concrete, (b) photo shows use of felt or fiberboard bearing material which may contain asbestos, (c) shows location of adhesive mastic with possible asbestos, and (d) photo shows possible use of coatings with ACMS on wood.

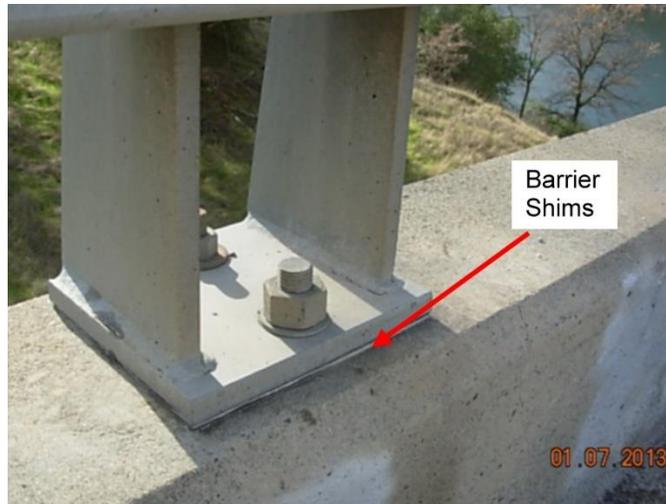
Figure 2.2 Barrier rail shims with ACM (Caltrans 2013)

The California Department of Transportation (Caltrans) produced an asbestos and lead containing paint survey report for the Tuolumne River Bridge (Caltrans 2013). The project focused on collecting bulk samples for chemical analysis. Six representative samples were selected from the bridge pads, concrete, and barrier rail shims (sheet packing). Laboratory analysis indicated 70 percent of chrysotile asbestos in the barrier rail shims. Figure 2.2 shows the location of these barrier shims, which are used to separate the rail baseplate from the concrete barrier. Interestingly, NESHAP did not require the removal of the asbestos containing barrier shims prior to renovations.

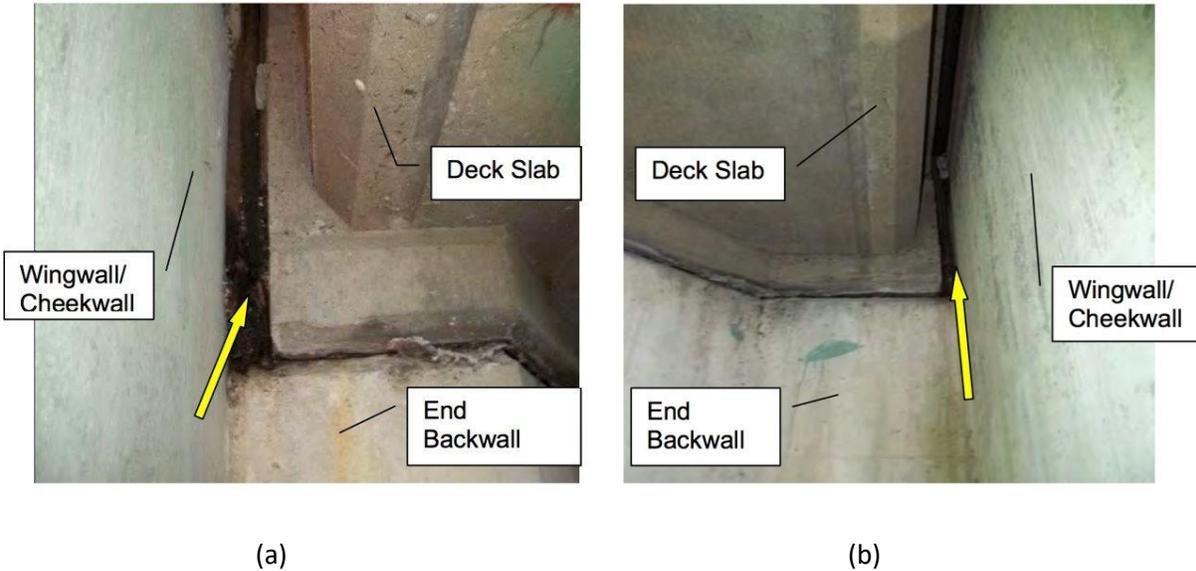
Figure 2.3 Location of joint filler with possible ACM (Environmental Planning & Management, Inc. 2013). (a) shows the south abutment at east wing wall, and (b) shows the south abutment at west wing wall.

The NYSDOT used a private consulting company (Stantec Consulting Services, Inc. 2013) to investigate the presence of ACMs in the west and east bound bridges of the Long Island Expressway (I-495) over Long Island Railroad (LIRR) in Calverton, Suffolk County, NY. The investigation was part of a 2013 bridge rehabilitation project. The bridges were built in 1970 and have a concrete deck supported by steel girders. The rehabilitation activities included the repair of spalling concrete, bearing replacements, and rehabilitation of the superstructure. The work consisted of reviewing bridge plans where asbestos materials, such as the sheets on the top of the back walls, deck joints, black bearing pads, grey sheet breakers in piers, brown joint fillers at the intersection of the deck and the wing walls, black slip sheets between the abutment and the bridge deck, and the black tar sealers on the longitudinal joints, may be encountered during the rehabilitation. Eighteen (18) samples were collected from these locations. Laboratory analysis revealed that the slip sheet and joint bond breaker material of both bridges, and the vertical joint filler between the wing walls and deck slab of the eastbound bridge contained ACM. Figure 2.3 shows the asbestos containing joint filler located between the wingwalls and the deck slab.

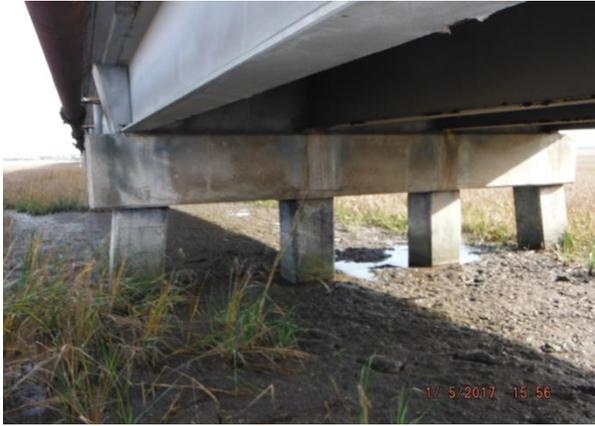
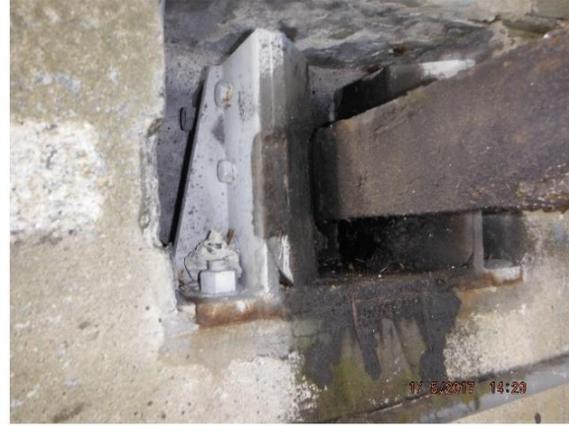
Figure 2.4 US-21 Sea Island Parkway Bridge over the Harbor River (F&ME Consultants 2017).
(a) bridge bents with joint-filler, and (b) swing braking parts

Figure 2.4 shows some of these locations. The figure on the left shows one of the bridge bents where the inspectors collected gray expansion joint like-materials. The figure in the right shows the swing part braking pad, where samples were not collected as the material did not appear to contain asbestos.

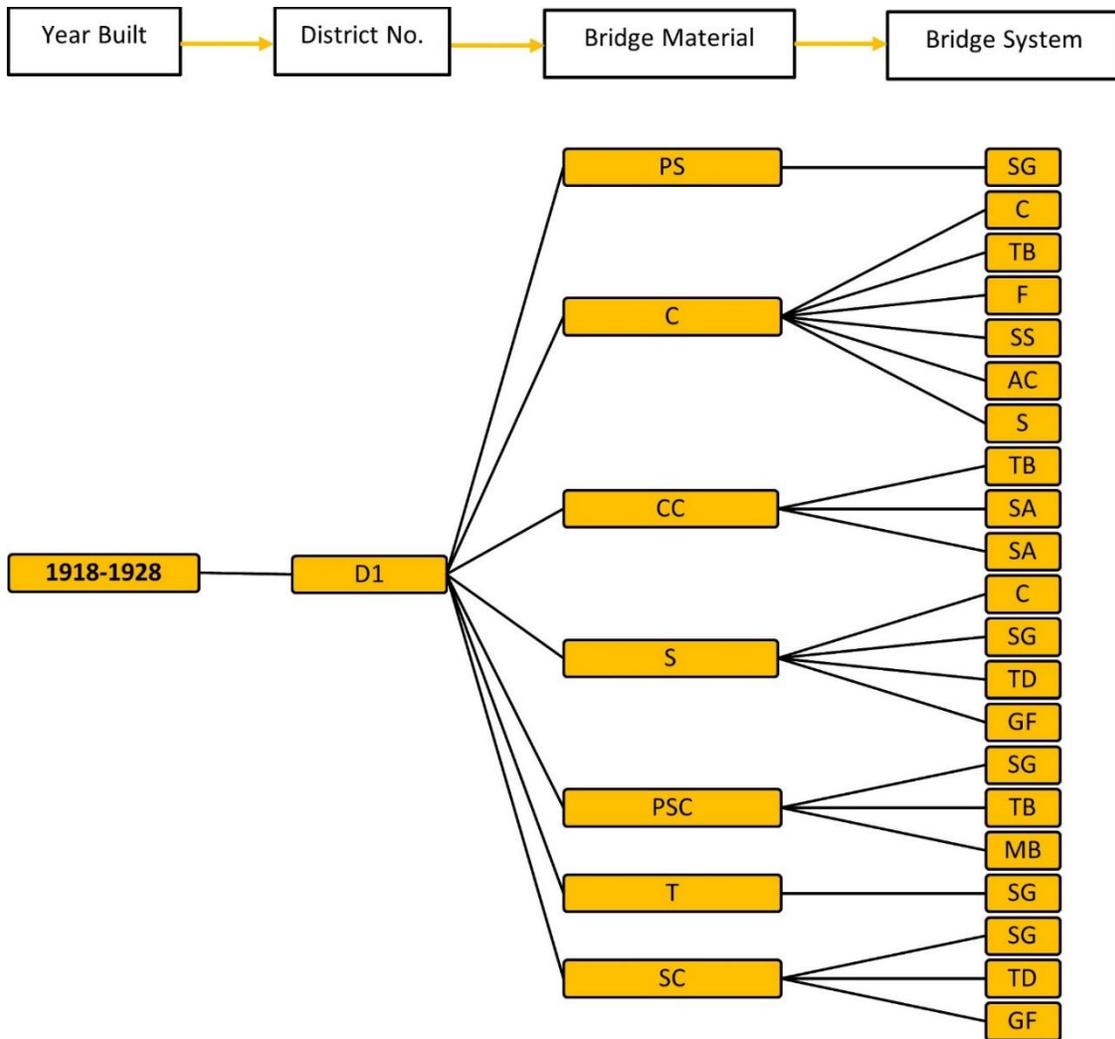
Figure 3.1 Flow chart showing the attributes used in review of as-built bridge plan

Figure 3.1 shows a flow chart of how bridge plans were selected and reviewed using the notation listed in Table 3.1. The review of bridge plans started with the bridge construction year followed by the district number and then the bridge material and finally by the bridge system design. The flow chart is an example of one set of plans that were reviewed by the research team. The review of bridge plans started with the year the bridge was built (first decade 1918-1928), followed by first district. Under district one, several bridges with various materials and structure systems were selected. This process was repeated for all the six districts and 62 years, which resulted in 253 bridges requiring a review.
