IDAHO TRANSPORTATION DEPARTMENT

SUBJECT: 2019 5010-1 Airport Inspection conducted August 26, 2019.
(04242.1A Copper Basin Mackay)

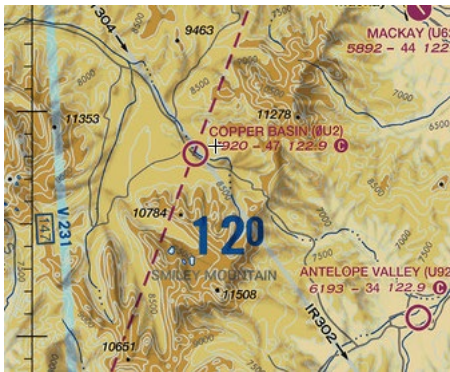
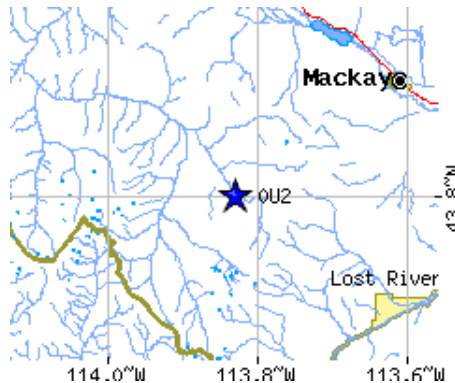
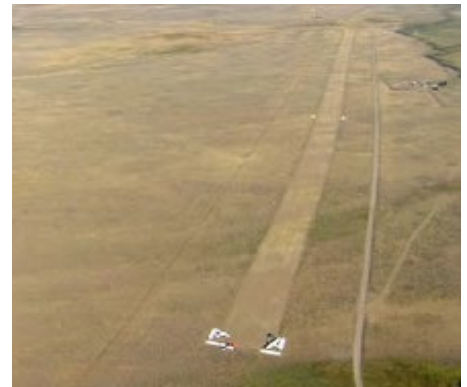
At the time of the inspection the runway surface I found to be in fair condition, with grass height of 15-20", and scattered 12-15" sagebrush plants. The runway was covered with bunch grass root bundles, which is the main reason for the runway roughness, and lots dried up cow pies. No badger holes were noted, in fact very little in the way of rodent activity was observed. The painted rock boundary markers had decent paint coverage and were mostly visible, especially on the SE corner of the airfield (rwy end 31). There was lots of

grass growth in and around the boundary markers particularly on the northwest – rwy end 13, but they continue to be visible from the air.
