SUBJECT: 2021 5010-1 Airport Inspections conducted 22 July 2021.

(04214.\*A Mahoney Creek Airport – 0U3 Mahoney Creek USFS) (04244.5\*A Indian Creek Airport – S81 Indian Creek USFS)

## Mahoney Airstrip (0U3)

## Indian Creek-USFS (S81)

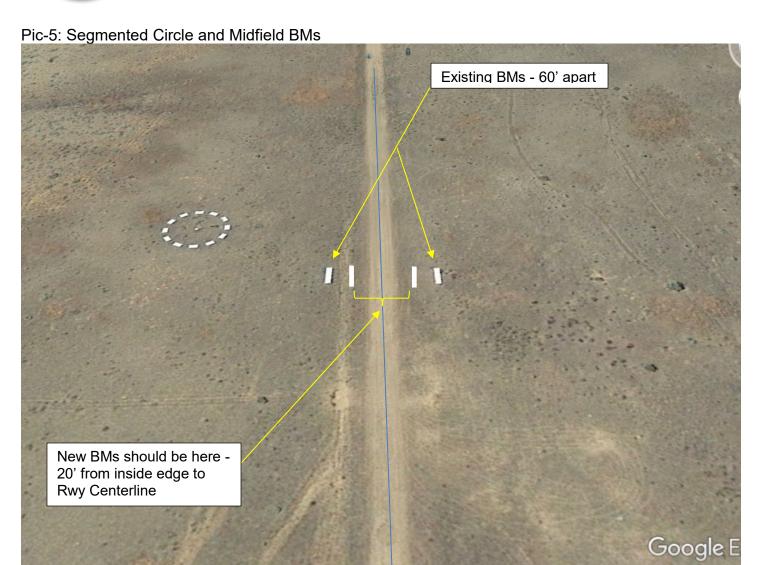
Pic-6: Runway End 4 - Overhead

**Boundary Markers (BMs):** The condition of the different wooden panels used as BMs on this airfield is good; however, the condition is not the issue as much as the placement of those markers. Currently, the markers are installed incorrectly and placed too far away from the centerline (see details in pic 4), which is inconsistent with the runway information reported on the FAA's Airport Master Record and certainly not in accordance with the Idaho Transportation Department - VFR Airports Design Manual.

changes, will minimize the potential for complaints/conflict between the flying public & your agency and will keep the unpleasant situations at a minimum, therefore, I recommend the following changes be made to the BMs (please refer to Pic 3, 4, 5 & 6):

- Area A (Rwy 22)-Pic 4: In-place, bring the BMs towards the rwy center so you would have no more than 25' max from the inside edges to the rwy, centerline, left and right as indicated in pic 4.
- Area B & C-Pic 5: in-place, bring all BMs towards the rwy center to have no more than 20' from the inside edges to therwy, centerline, both - left and right,
- Area D (Rwy 4)-Pic 6: bring the BMs forward 30' from current position and 25' apart from rwy. centerline – see explanation in pic 6.
- The size of the BM panels should be a minimum of 15'Lx4'W, but not smaller; larger is ok (20'x4' or 30'x5')
