IDAHO TRANSPORTATION DEPARTMENT

Subject: 2023 5010-1 Airport Inspection conducted May 11, 2023.
(04275.5*A New Meadows Airport New Meadows)

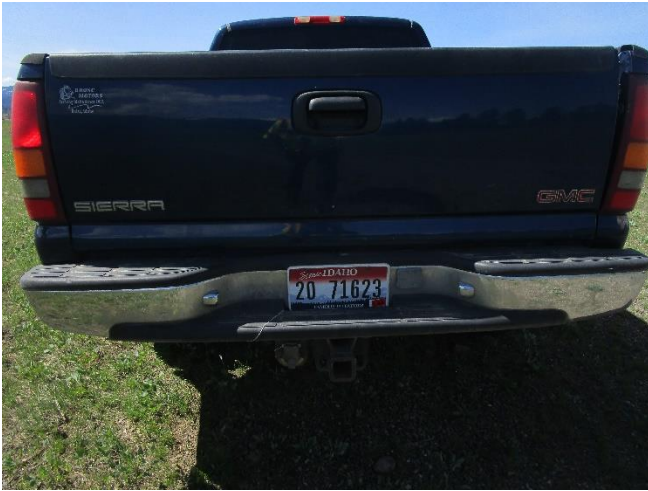
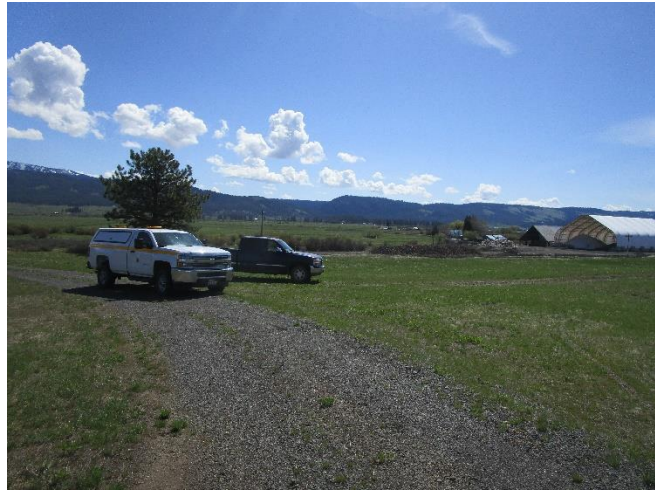
Misc/Other: The Idaho Power poles that are across Highway 95 showed good orange/white paint and were visible to all incoming aircraft. The fence had all the wires up and it appeared to be in good condition for the most part around the airport; the only exception was the portion on the approach to rwy. end 14 where the barbwire fence is leaning away from the airport. All signs were in good shape, visible, and none broken. Overall, I found the airport to be in good condition. The last thing I wanted to mention is the truck that I found parked on the airport behind the closed and locked gate – do you know anything about it? I am not sure what to make of it but here are a couple of picks showing where it is parked on the airfield. Is it supposed to be there?
