**RP 270**

# **Development of an Inventory and Inspection Database Framework for Asset Management of MSE Walls**

July 2019

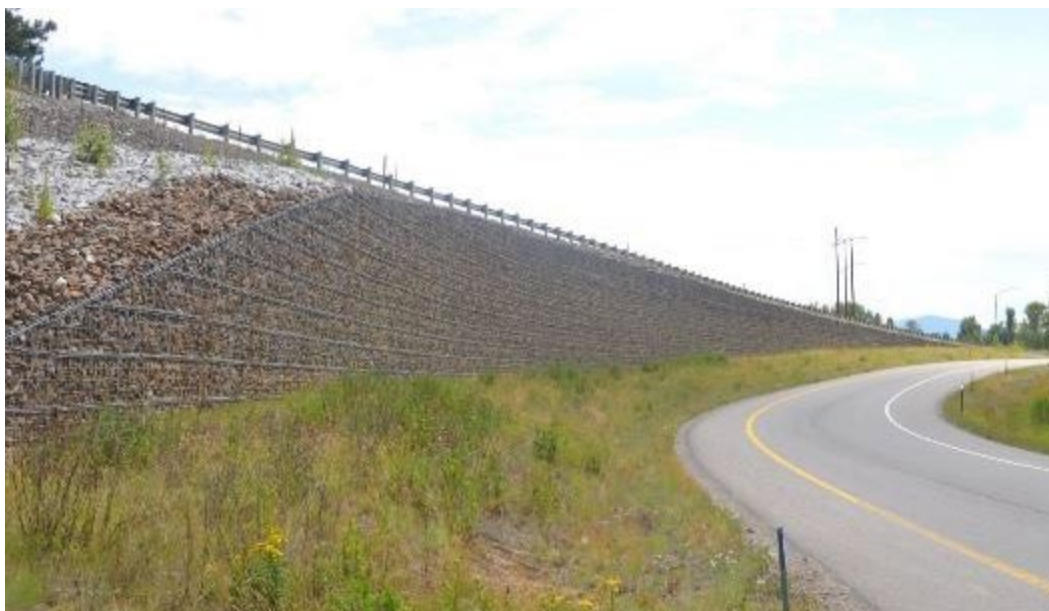
**Figure 11. Wire-Gabion MSE Wall at MP 475, SB US-95 in Sandpoint**

With no problems observed, it can be concluded that the wall is performing as expected.

The three inspection procedures being evaluated only address MSE walls with concrete panels. Hence, the section concerning the performance of wall panels was modified to address issues likely to affect MSE walls with wire gabions. The completed evaluations using the three protocols are included in Appendix B.

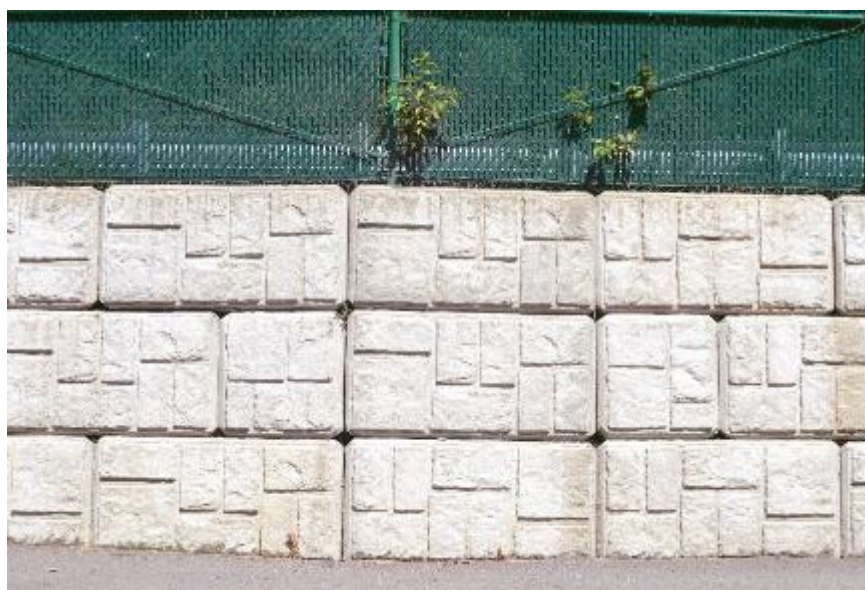
This is a 330-foot long, MSE concrete block wall which supports the SB lane of SH-200 near Trestle Creek. This wall was constructed in 2013 and consists of stacked concrete blocks as shown in Figures 13 and 14. The maximum height of this wall is 8.5 feet. The inspection revealed no problems with alignment, settlement, or block degradation. There was some minor staining, but there were no obvious signs of leaking backfill or drainage problems. The completed inspection forms are included in Appendix B.

**Figure 13. Concrete Block Wall near Trestle Creek, SB SH-200**

**Figure 14. Concrete Block with “Cut-Stone” Finish used for Trestle Creek Wall**

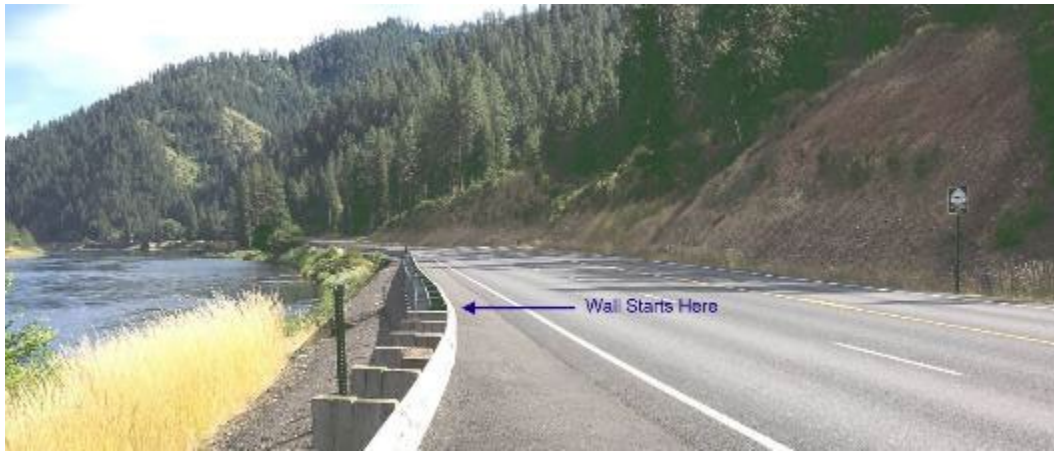
Figures 17 and 18 show the start of the eastern wall at MP 53.59, which is about 650 feet long and has a maximum height of about 15 feet. As in the western wall, a woven geosynthetic mesh is used to retain the finer gabion backfill, as shown in Figure 18. These gabions are also made of Corten-steel which has developed the typical rust coating.

Only the edges of the wall could be accessed for inspection due to the steep, vegetated terrain next to the Clearwater River. There were no signs of excessive corrosion or leakage of gabion fill materials, and no adverse observations noted during the site visit.

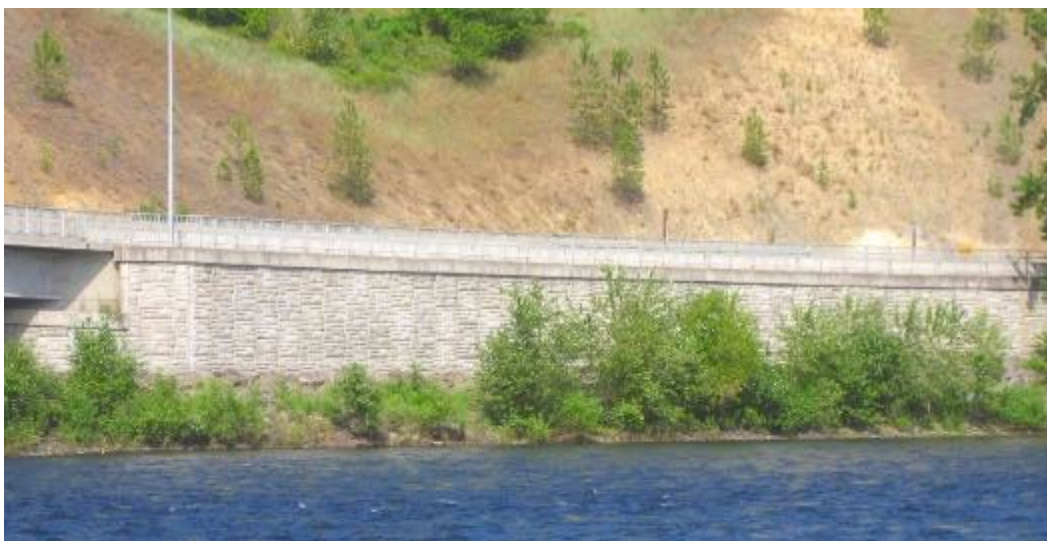
Overall the MSE wall is in good condition, with only minor staining, no obvious distress in the concrete panels, and all panel joints have uniform spacing. The rip-rap (up to 3-feet in diameter) placed at the base of the wall is performing well as there were no obvious signs of erosion due to scour. The wall did not have any vegetation growth in the panel joints and only limited vegetation growth on the road side of the coping. The inspection forms for this MSE wall are not included as the wall is performing very well and no adverse features were observed during the field investigation.

**Figure 19. View of Kamiah Bridge Eastern MSE Wall, EB US-12, from across the River**

**Figure 20. Closer View of Eastern MSE Wall of Kamiah Bridge from the Deck**

This wall is an excellent candidate for future condition surveys performed by sUAV (“drone”) technology due to its inaccessibility adjacent to the Clearwater River.

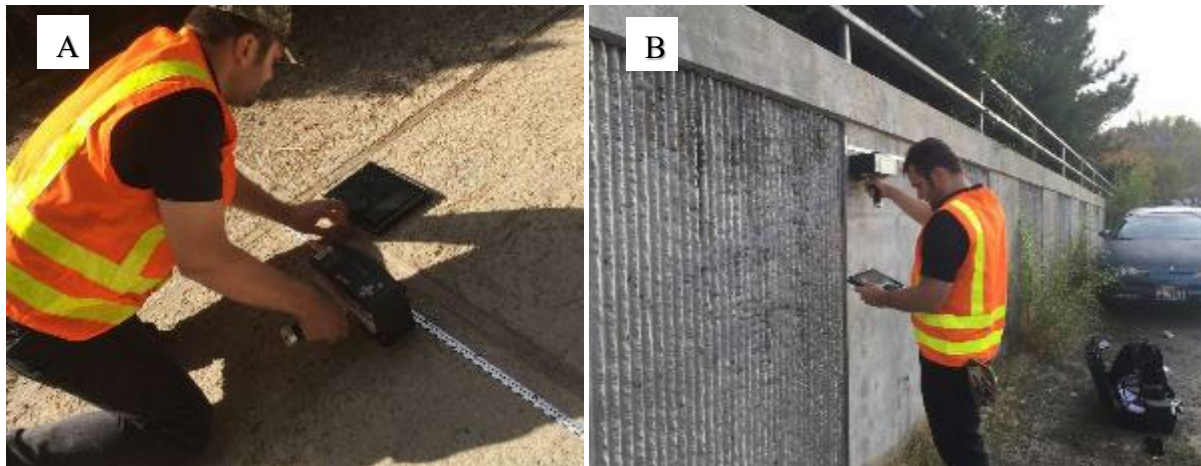
**Figure 45. Ultrasound measurements taken at A: Site D3-2, B: Site D3-3**

The device used to study delamination in the current MSE wall project is the wireless Pundit Live Array Pro tomography scanner. It is connected with an iOS app to an Apple® iPad. The device comes with Artificial Intelligence (A.I.), user support and 3D imaging capabilities.<sup>(45)</sup> Figures 45A and 45B show data collection on a concrete bridge apron and a retaining wall.
