Subject: Asbestos Evaluation Report  
US-91, Park Lawn to Siphon Road (KN 21860)  
Chubbuck, Idaho

US-91, Roadway Widening, Park Lawn to  
Siphon Rd  
MP 81.138 to MP 81.620

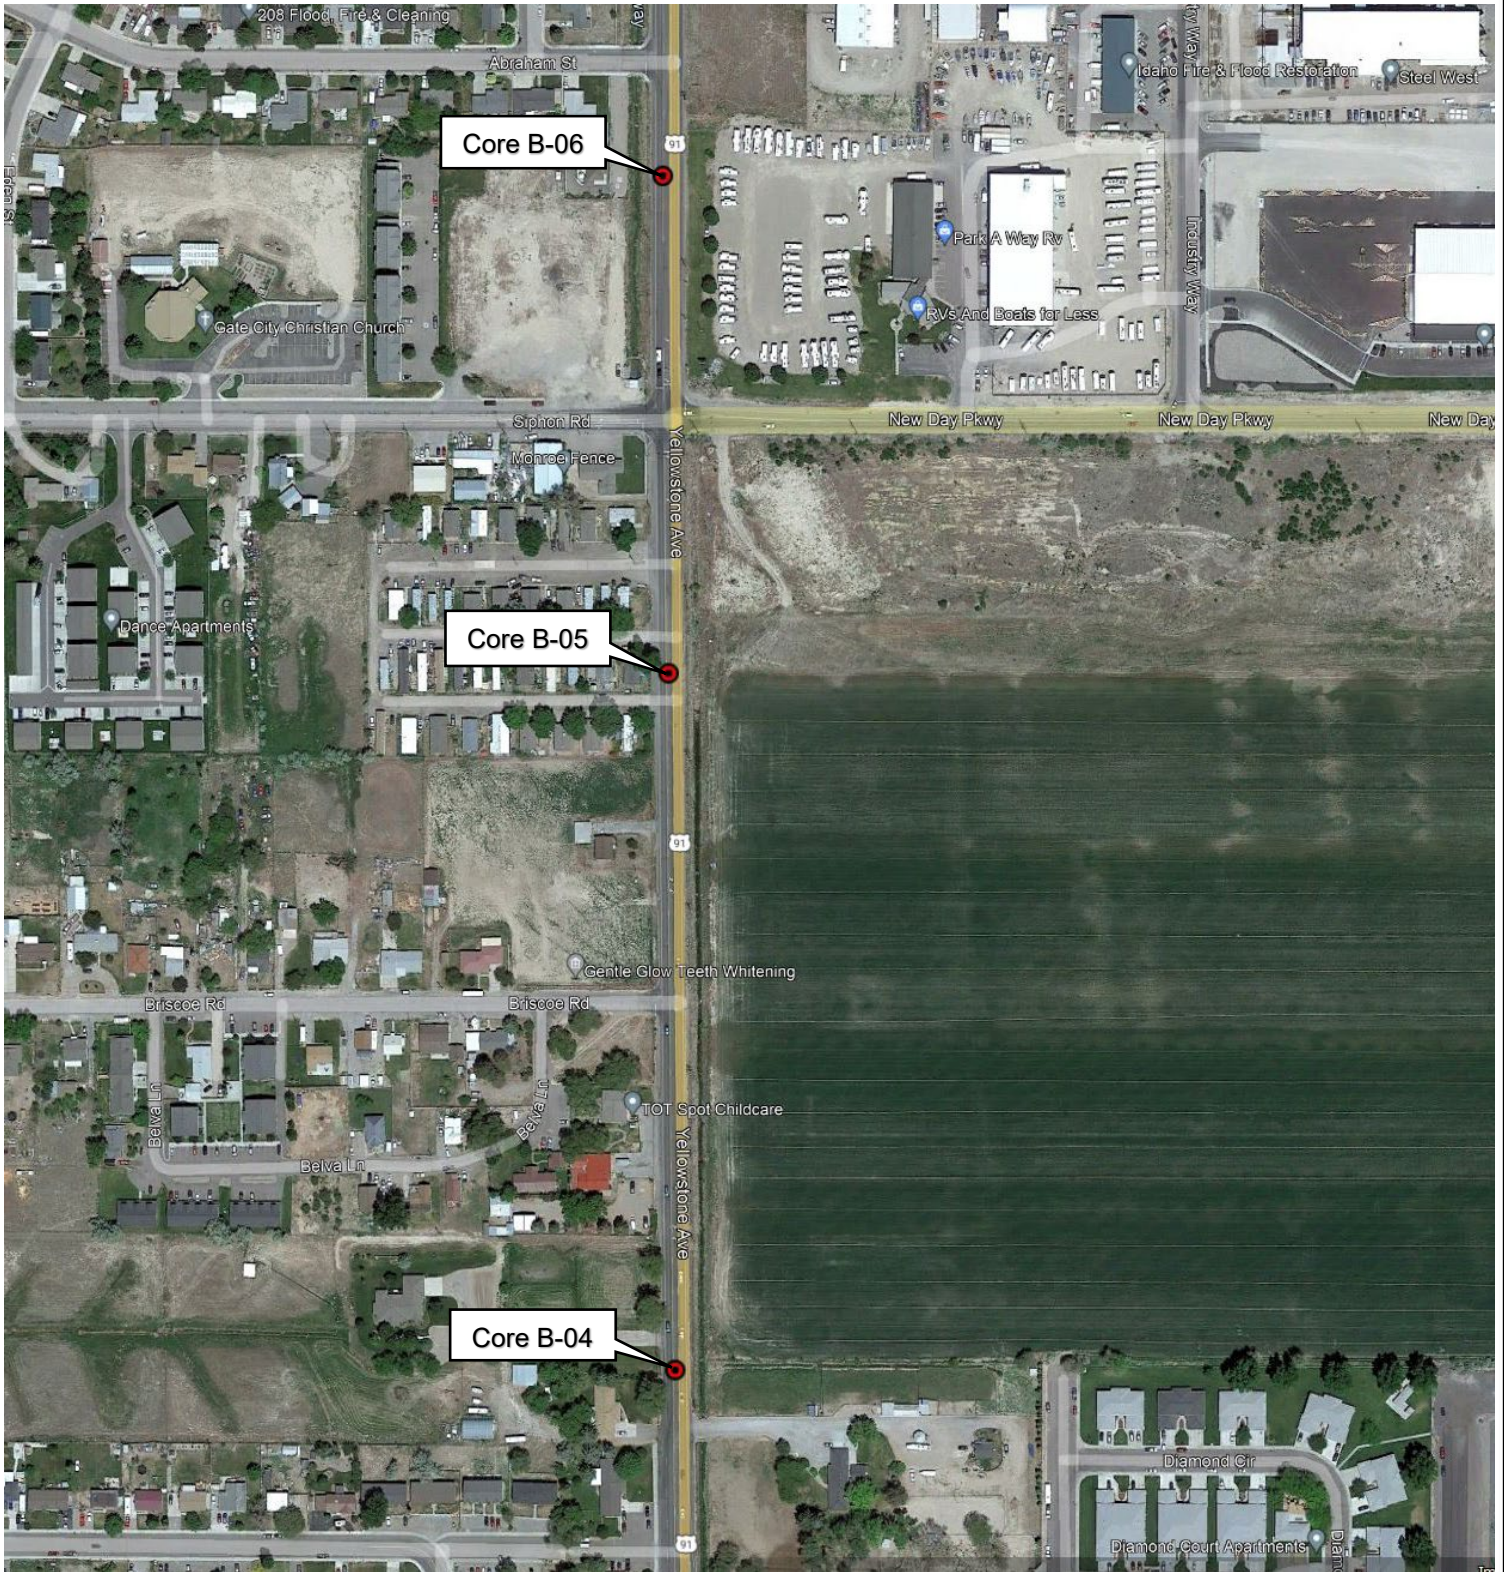
A PCC Core Location Map (Fig. 1) and Asbestos Bulk Sample Analysis Report are attached.

NOT TO SCALE

Three buried PCC cores were collected by Shannon & Wilson on January 12, 2023, as part of the Roadway Materials evaluation. The core samples were crushed by the Shannon & Wilson laboratory then sent to Atlas Technical Consultants for asbestos analysis. The results from all samples were, "No Asbestos Detected (NAD)" indicating that asbestos was not detected in the existing PCC.
