DURABILITY OF METAL PIPE CULVERTS

STATE OF IDAHO DEPARTMENT OF HIGHWAYS

A STUDY OF THE DURABILITY OF METAL PIPE CULVERTS

April, 1965

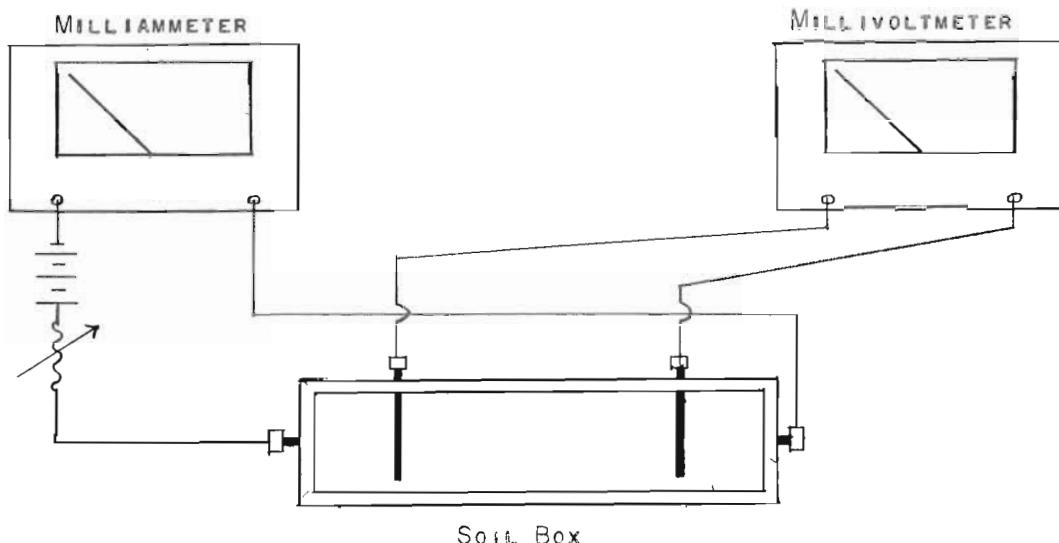
3. (a) APPARATUS.

- (1) MILLIAMMETER
- (2) VACUUM TUBE VOLTMETER
- (3) CALIBRATED SOIL BOX
- (4) No. 8 SIEVE
- (5) ROUND ENAMELED PAN, 8-IN. DIAMETER AND 3 INCHES DEEP
- (6) STAINLESS STEEL SPOON, 13 IN. LONG
- (7) BALANCE, 2000 G. CAPACITY, ACCURATE TO 5 G.
- (8) WIRING DIAGRAM

(1) PASS WELL-MIXED REASONABLY DRY SOIL THROUGH A NO. 8 SIEVE. WEIGH OUT 650 G. OF THE SOIL SAMPLE AND PUT INTO AN 8-IN. ROUND PAN. ADD 75 ML. DISTILLED WATER TO THE SOIL AND MIX. PLACE THE MIXTURE INTO THE SOIL BOX, COMPACT IT, (MODERATE COMPACTION WITH THE FINGERS IS SUFFICIENT) AND MEASURE RESISTIVITY. REMOVE THE MIXTURE FROM THE SOIL BOX AND PUT BACK INTO THE PAN. ADD AN ADDITIONAL 50 ML. DISTILLED WATER, MIX THOROUGHLY, COMPACT SOIL IN BOX AND MEASURE RESISTIVITY. REPEAT PROCEDURE ONCE MORE. IF RESISTIVITY OF SOIL HAS NOT FOLLOWED A TREND OF HIGH RESISTIVITY, LOW RESISTIVITY, AND THEN AN INCREASE IN RESISTIVITY, CONTINUE TO ADD 50 ML. INCREMENTS OF WATER TO SOIL UNTIL THE MINIMUM RESISTIVITY IS OBTAINED.

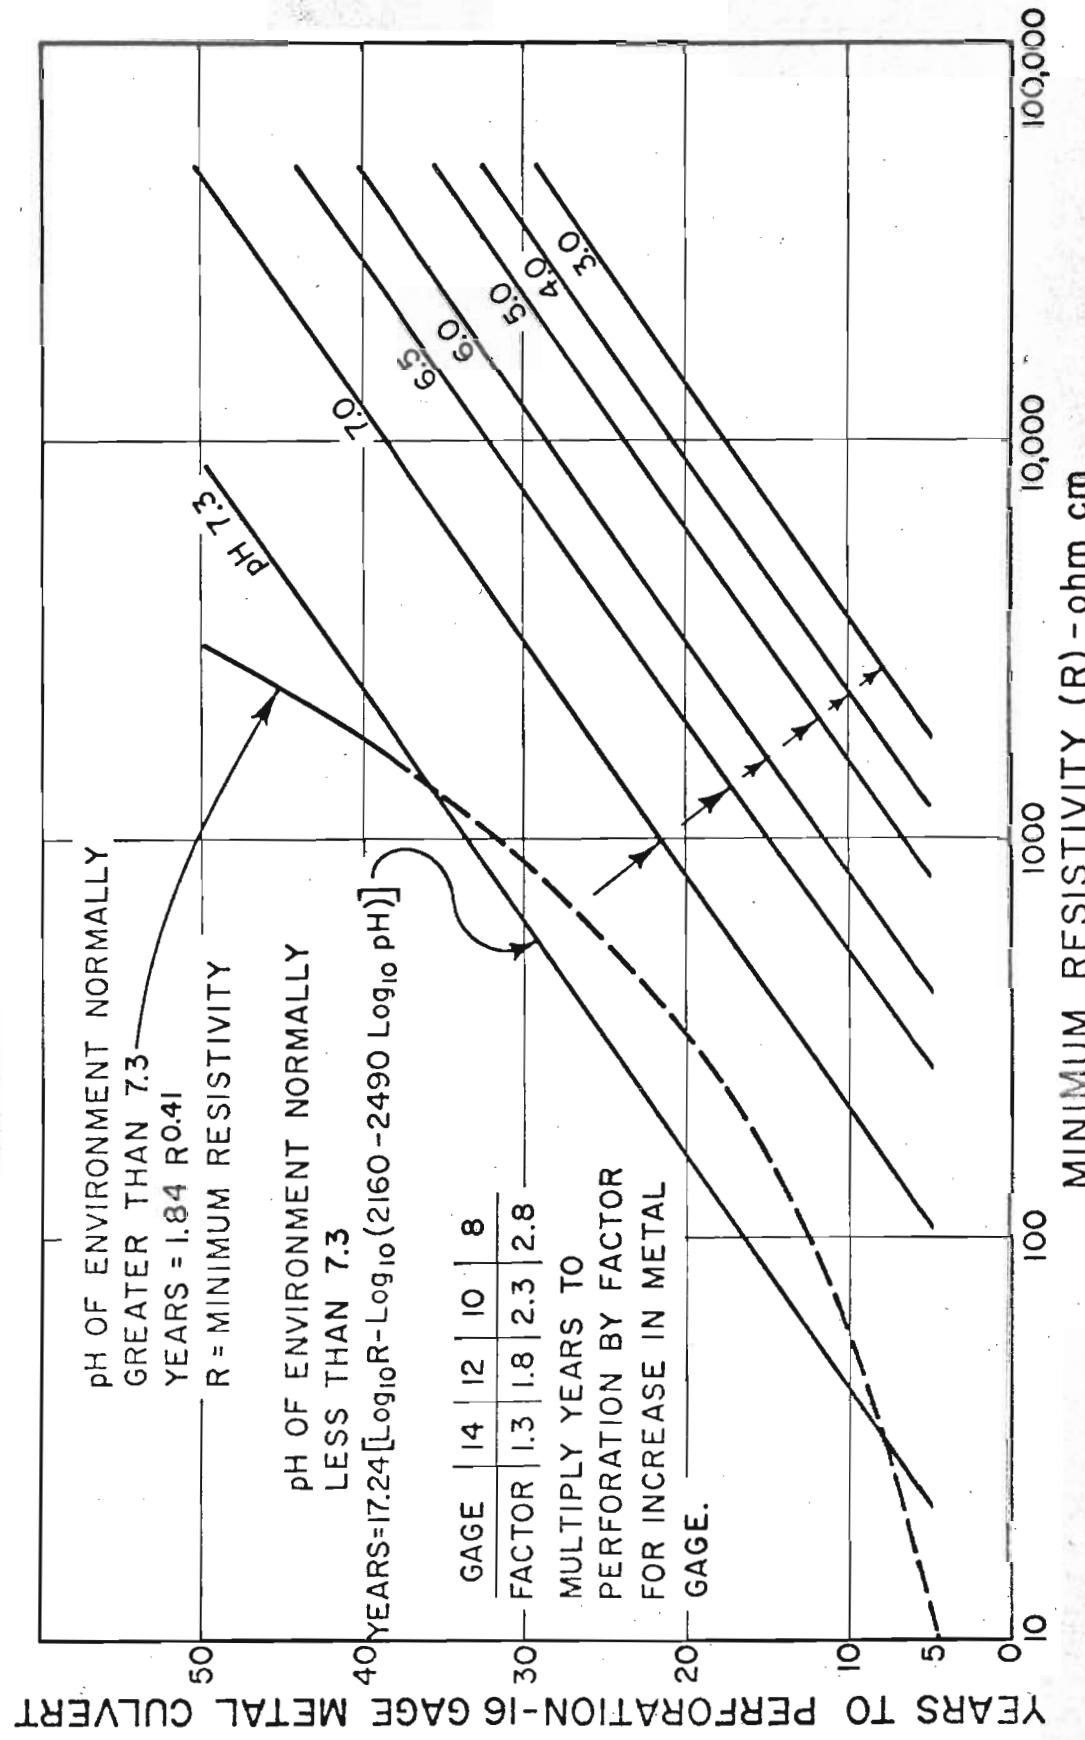
CHART FOR ESTIMATING YEARS
TO PERFORATION OF METAL CULVERTS

CHART FOR ESTIMATING METAL CULVERT SERVICE LIFE
CALIFORNIA DIVISION OF HIGHWAYS

The test devised by the California Highway Department using soil pH and electrical resistivity appears to give a satisfactory estimate of service life, although few installations are of an age to verify the predicted life.

It is recommended that the California test and criteria be used as a guide to the service life of pipe.
