5010 AIRPORT INSPECTION FORM/REPORT

Airport: SODA SPRINGS LocID: U78 (Paved) Undevelopd NPIAS: Y (N) INSP Date: 10 Jun 21

Allen Tygert/Soda Springs Airport Pictures - 10 Jun 2021

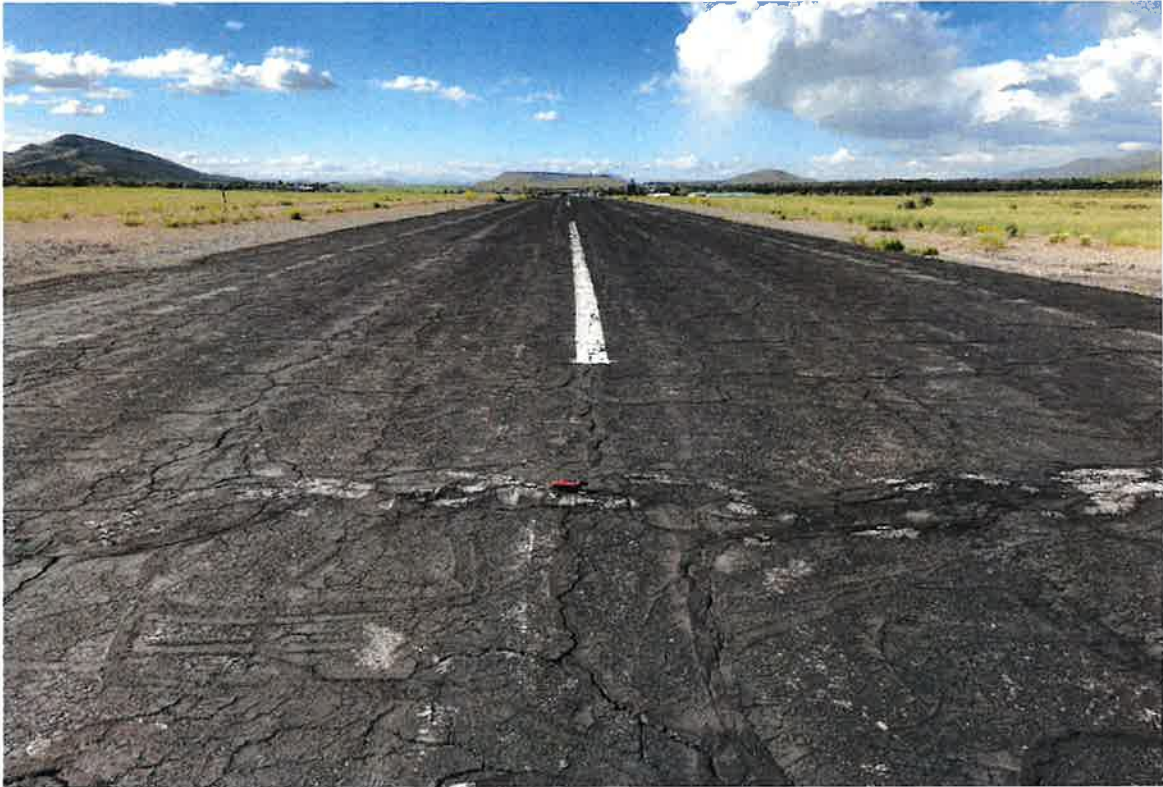
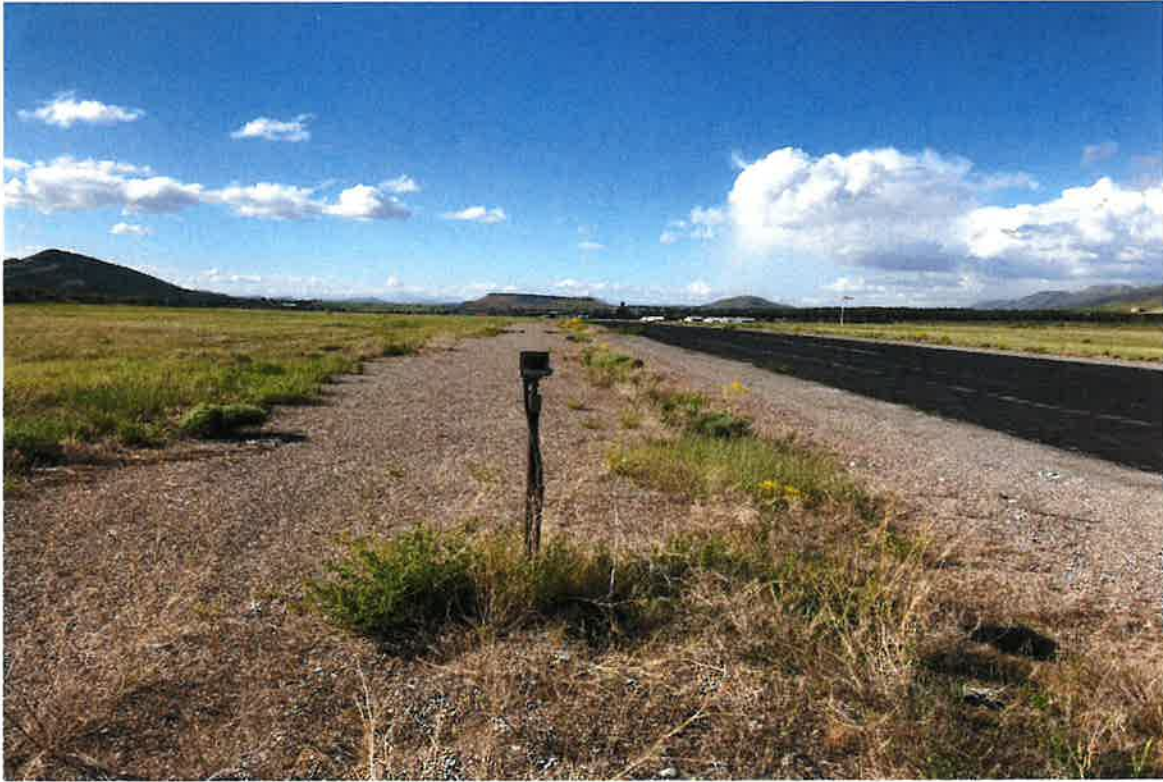
Remarks: BMs = Boundary Markers // CL= Center line // THIS RWY IS NOT V. WELL KEPT; IT'S IN POOR CONDITION, HAS NO MARKINGS & NO LIGHTS. PAVT HAS LOTS OF CRACKS W/ GRASS GROWING THROUGH; NEEDS NEW PAVT.

Remarks: THIS IS THE RWY THAT GETS USED THE MOST & IT NEEDS LOTS OF TLC. SFC PAVT IS IN DIRE NEEDS OF REPAIRS AS SFC IS PLEGGED BY LOTS & LOTS OF CRACKS - SOME OLD & TREATED & SOME NEW & UNTREATED; NEW PAVT WOULD BE NICE.

Ramp/TieDown Area Sfc Type: ASPHALT Sfc Cond: POOR # of Spots: 4 # w/Chains/TDs: 0 VEH/RY Markings: Y (N) Lights: N/A Signs: Y (N) Veg Ctrl: GOOD FUNCTIONALITY Remarks: RAMP AREA IS ALSO IN ROUGH SHAPE - HAS AREAS OF MISSING ASPHALT W/ LOOSE GVL IN FRONT OF PILOT'S LOUNGE. OF WHAT IS LEFT.
